FINAL REPORT
SPACE SHUTTLE POWERED ELECTRICAL
CONNECTOR DE-MATE TESTS

SUBJECT: Final Report for Contract "Space Shuttle Powered
Electrical Connector De-mate Tests - P. O. #T-2862T

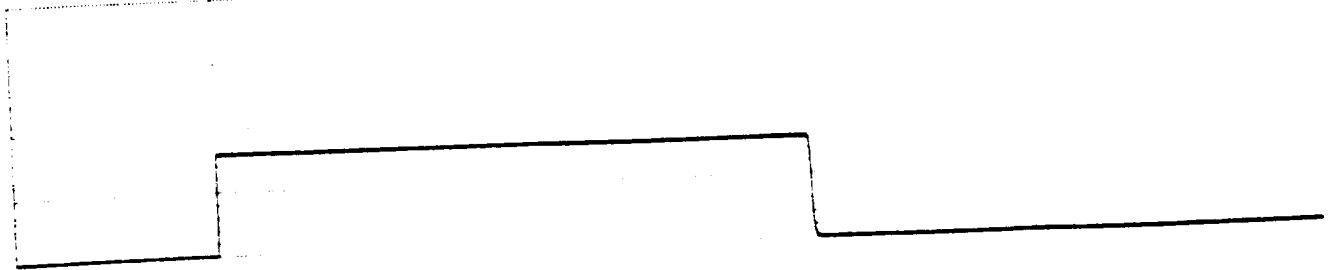
Figure 12

At 33V/23.1A, more plating was vaporized from the pin tip and the edge of the socket melted down. The pin/socket pair probably could not be remated.

33V 23.1A 169A
